**Radwinter Conservation Area Appraisal and Management
Proposals, Approved January 2013**

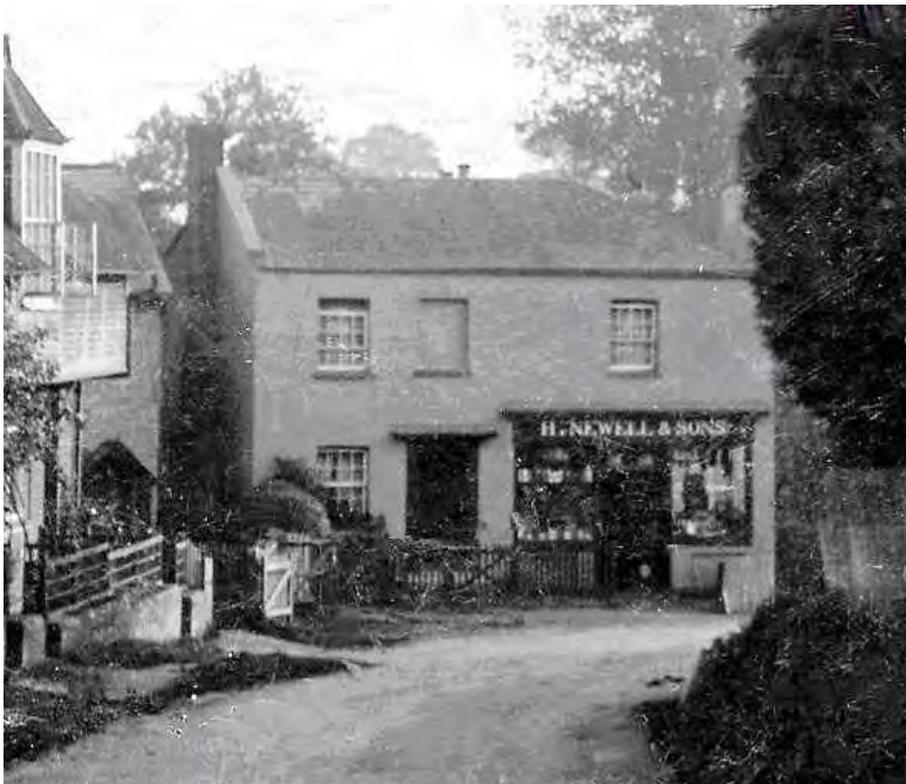
1.33 Unfortunately there are no other unlisted buildings of architectural and historic interest that add to Radwinter's overall quality. Whilst several other 19th century buildings exist at Church Hill and Princes Well their original character has been significantly changed by extensions and alterations. Additionally associated off street car parking has resulted in a serious erosion of the quality of the Conservation Area here. The evolution of one 19th century historic building is described below.

Picture 1.1 Traditional village shop and residence early/mid 20th century

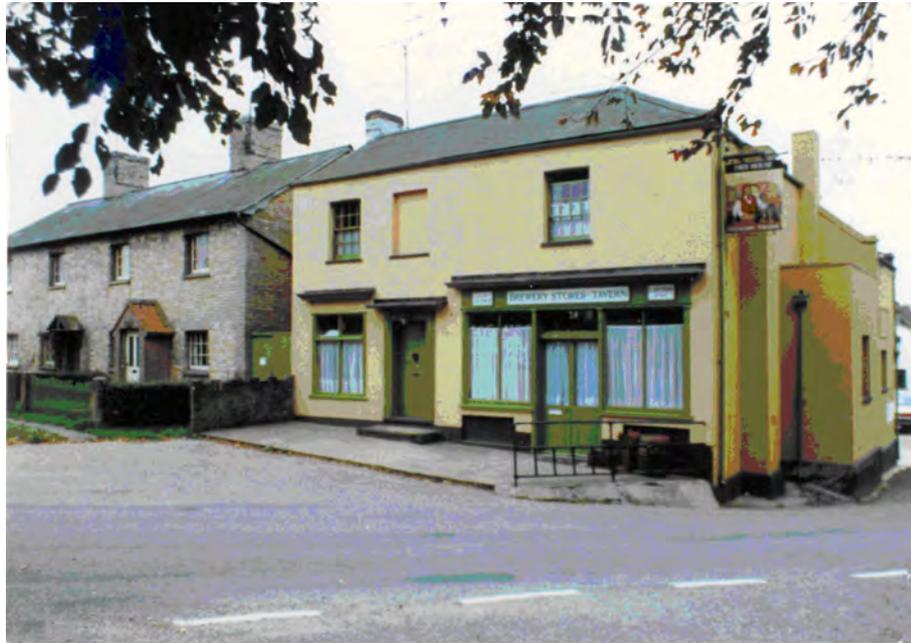
Picture 1.2 Traditional village shop and residence, mid/late 20th century, additional use as Brewery Tavern and enlarged window to left added. Also note porches of differing styles and scales added to adjoining 19th century terrace

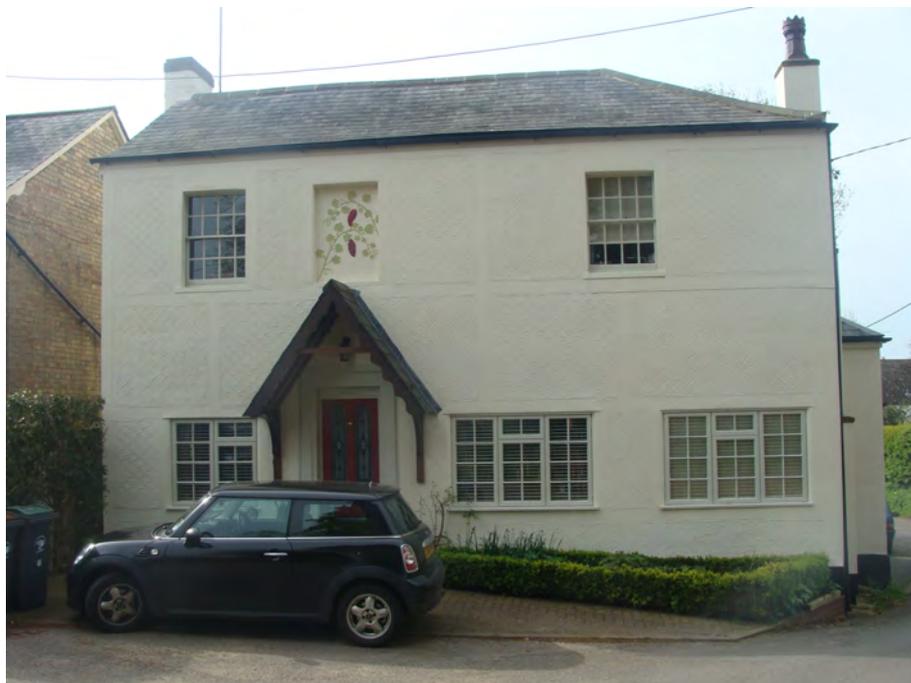
Picture 1.3 The building today, original commercial window detailing replaced and large central porch added. Change of use may have been inevitable but a more appropriate design solution retaining some original features would have been possible

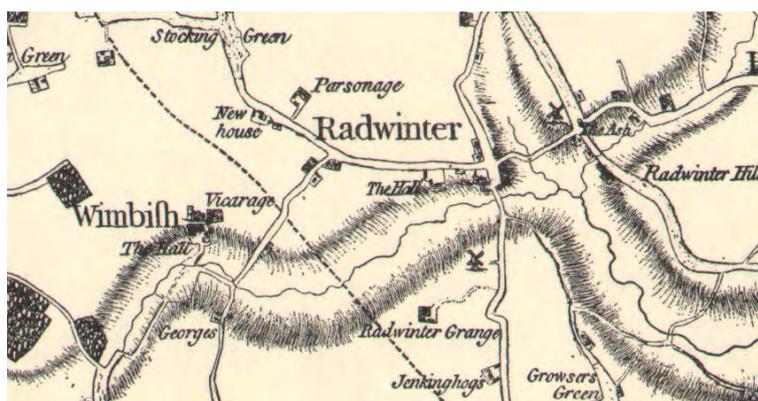
Picture 1.4 Radwinter, essentially unchanged from the Medieval period, as shown in the 1777 Chapman and Andre survey (Courtesy of Saffron Walden Museum)

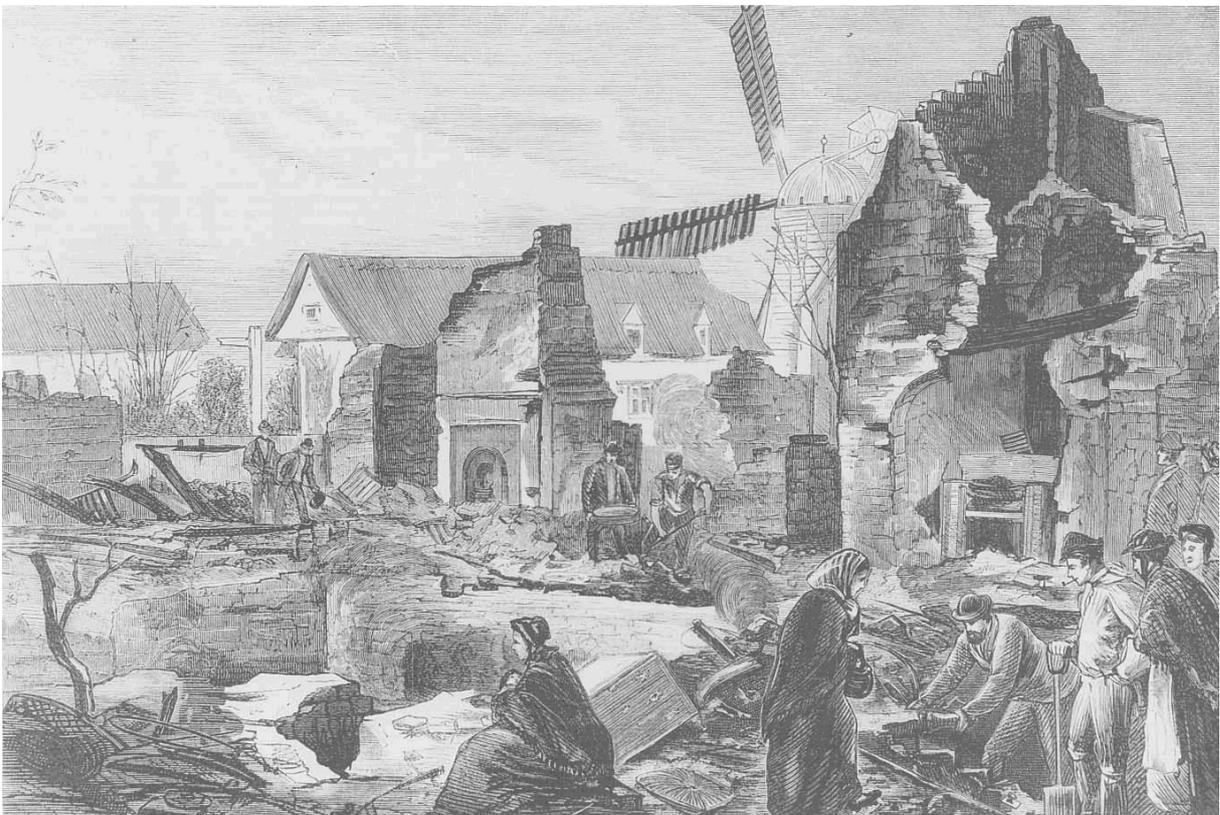
Picture 1.5 Contemporary drawing of the fire of 1874. Note Corn Mill, formerly off Water Lane adjacent to present day Recreation Ground

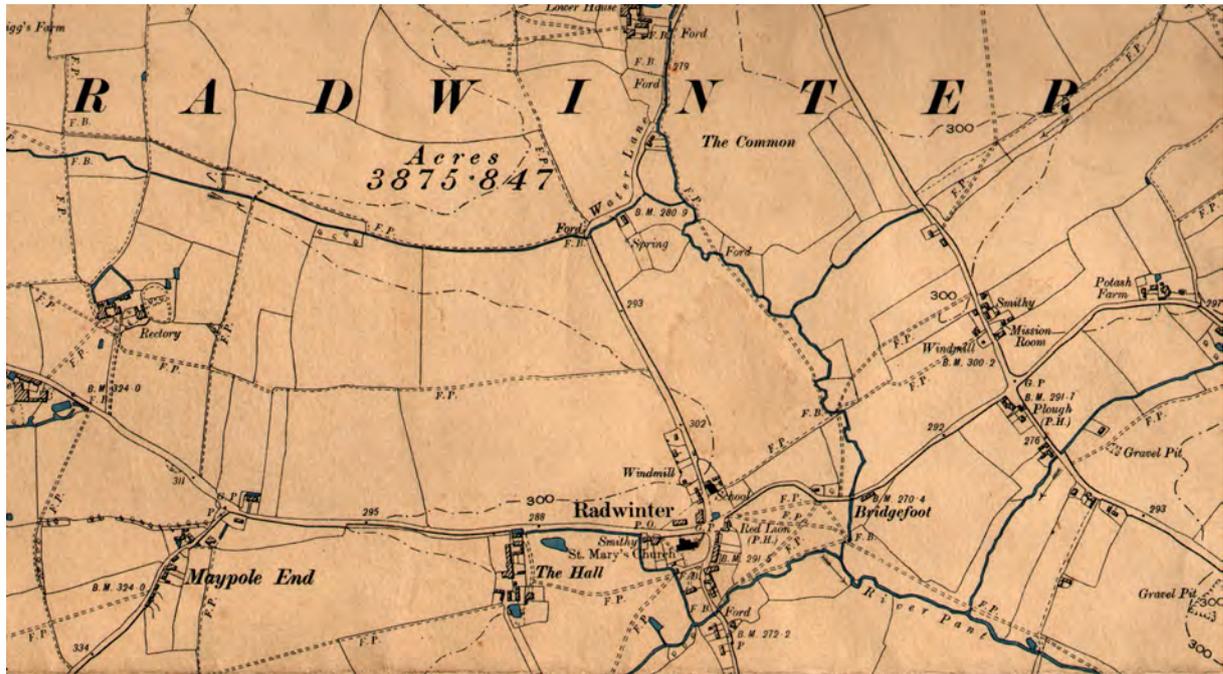
Picture 1.7 Radwinter as shown on the 1898 Second Edition Ordnance Survey (Courtesy of Saffron Walden Museum)

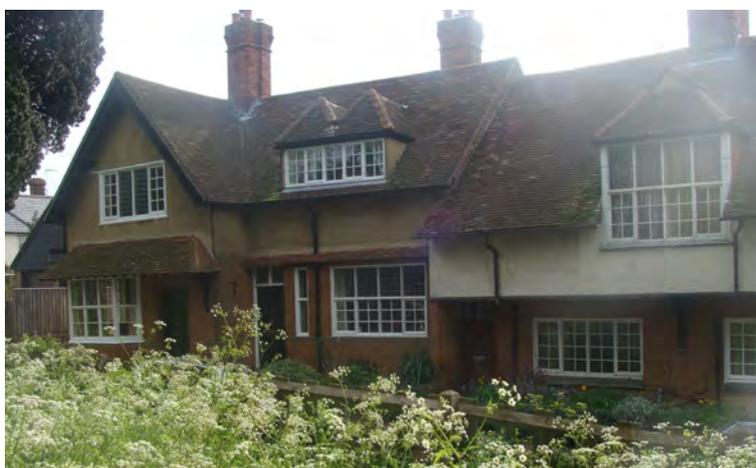
1.62 G. D. Murray (shop premises) and Nos. 1 to 4 Church Hill- Grade II. Range of houses and a shop to the east of the church. Built by W. E. Nesfield, architect in 1875. Two storeys. The ground storey is of red brick and the upper storey is plastered, with pargetted panels. A short gabled wing projects on the front at the north end with a shop bay window and doorway under a tiled canopy. The upper storey to Nos. 2 to 4 is jettied. The windows generally are casements but the shop and No. 1 have mullioned and transomed windows. Roofs tiled, with hipped dormers of different sizes. *No longer a shop.*

Picture 1.8 Important houses by W. E. Nesfield built after the great fire of 1874

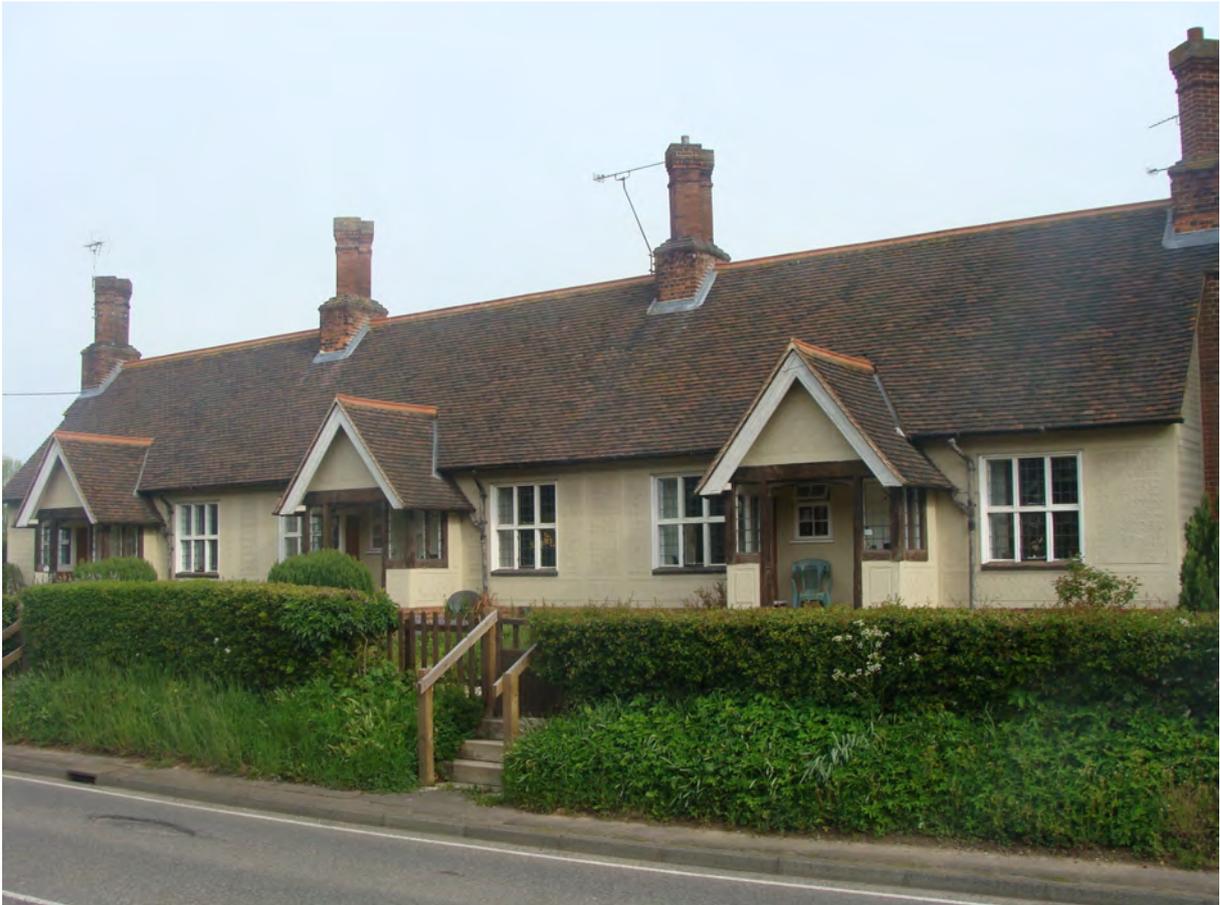
1.63 Almshouses Nos. 1, 2 and 3 Ashdon Road - Grade II. Range of almshouses built by W. E. Nesfield, architect, in 1887. The walls are plastered, with pargetted panels, on a red brick base. The windows are casements with leaded lights and wood mullions and transoms. Three gabled porches project on the front. Roofs tiled, with 4 chimney stacks each with 2 square shafts set diagonally on a square base. *James Bettley and Pevsner advise these were in fact designed by Temple Moore, a protégé of Nesfield.*

Picture 1.9 Alms Houses designed by Nesfield and/or Temple Moore

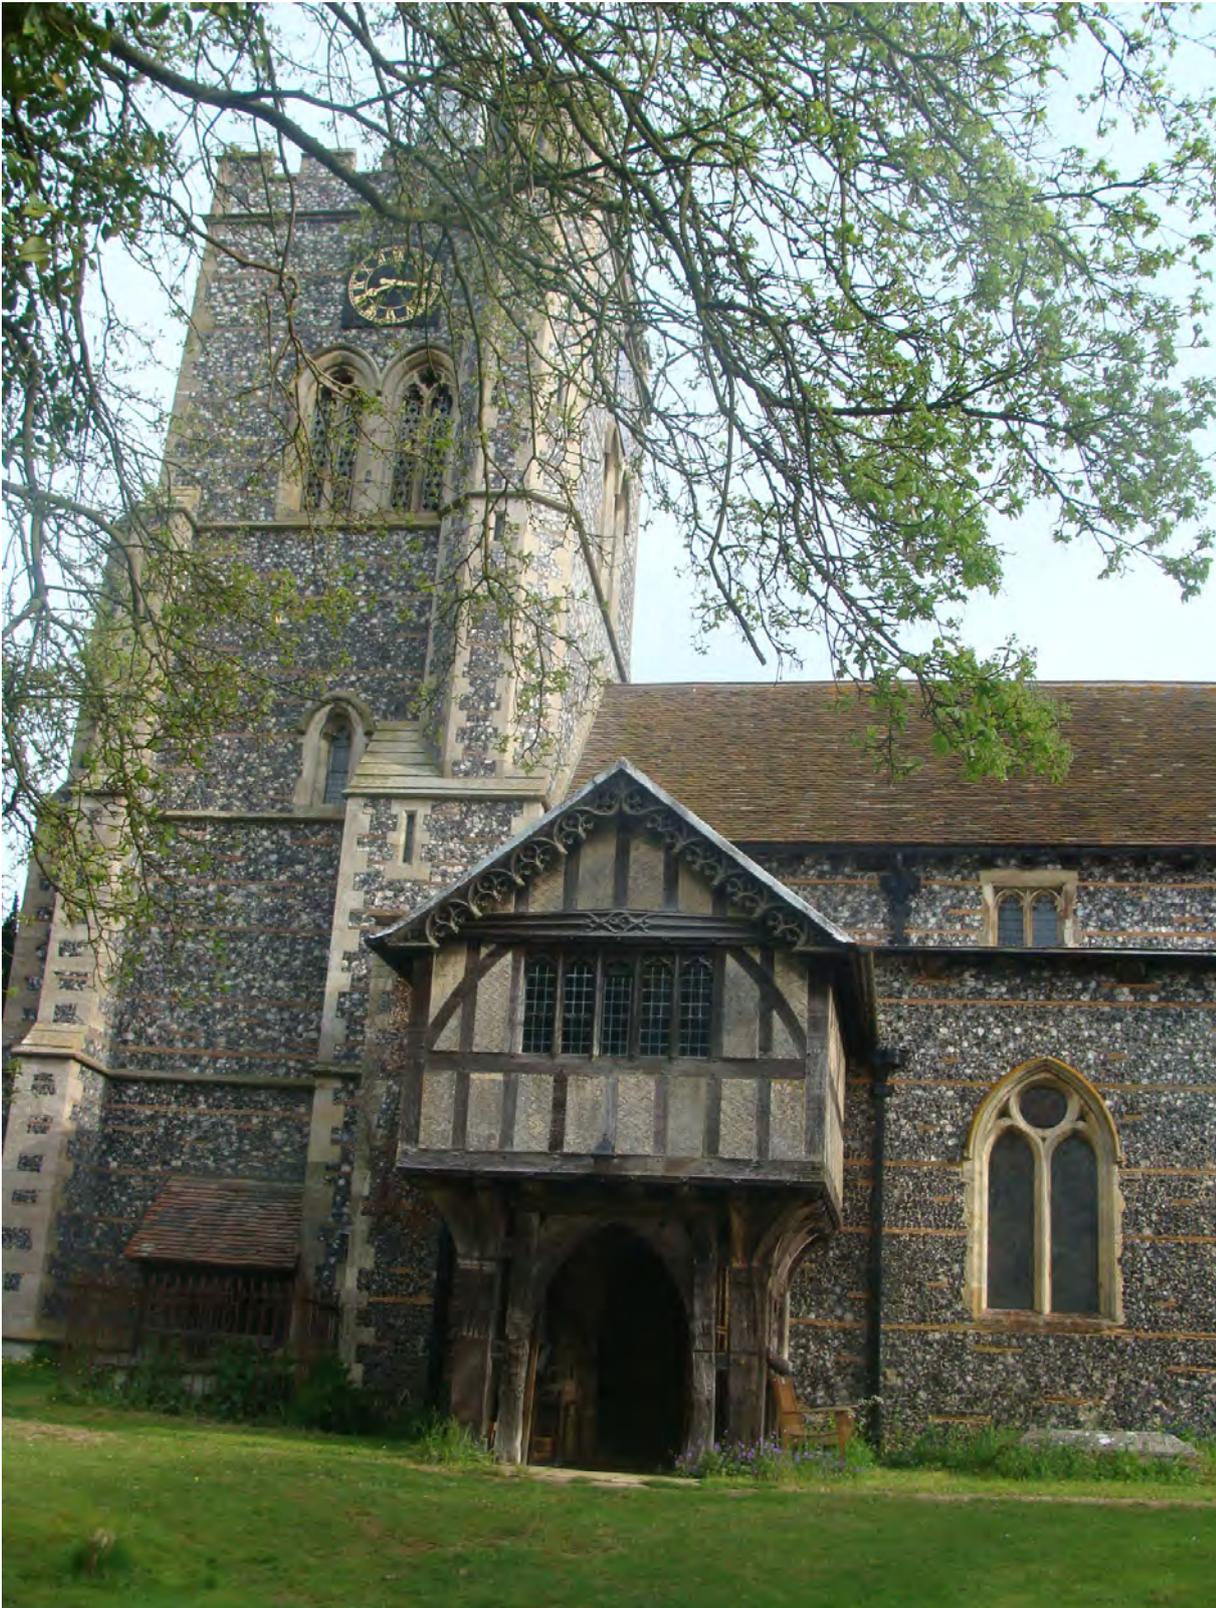
1.64 Church of St Mary the Virgin - Grade II*. Flint church almost completely rebuilt in 1869-70 by W. E. Nesfield. He left the lower stage of the fine 14th century south porch and the north arcade of the nave which is circa 1340. He added the gabled framed upper storey of the south porch. The nave roof is 14th century. The west tower, with castellated parapet, angle buttresses staircase turret and small spire was added in 1887 by Temple Moore. The church reconstruction with a number of surrounding buildings is an important work of W. E. Nesfield. *Within the church is a rare 16th century wooden Reredos made in Brussels and bought by Bullock; 19th century side wings by unknown artist were commissioned by Temple Moore. Fine stained glass throughout; one scene has given biblical characters the contemporary faces of Gladstone, the Prime Minister (a very good likeness) and Lord Salisbury, for example. Also other fine paintings and other internal features by Temple Moore and Nesfield.*

Picture 1.10 Radwinter church, note similarity of porch with Nesfield's original sketch, see Picture 1.5 above

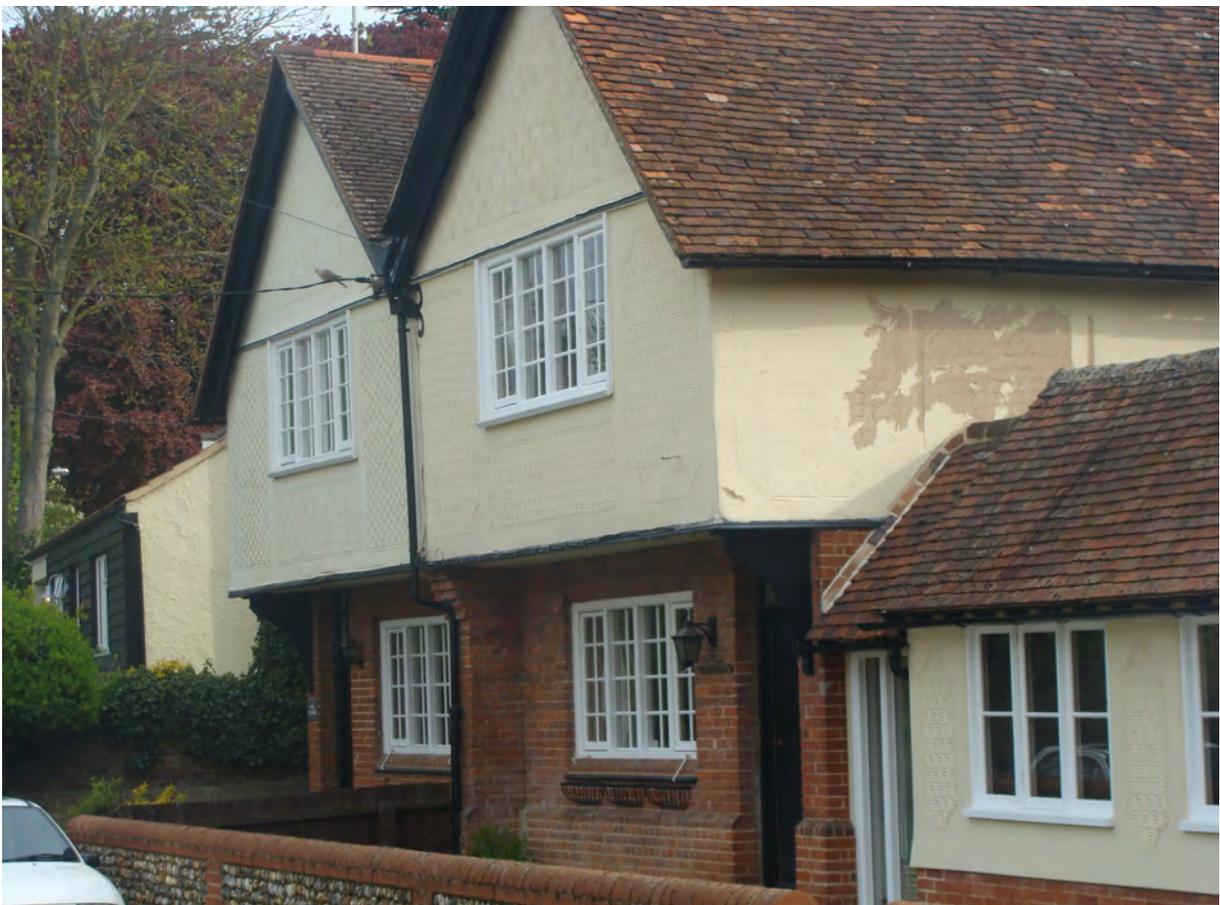
1.65 Brookside Cottages including outbuilding to south, Princes Well - Grade II. Pair of cottages and outbuilding, formerly a tailor's shop. Circa 1875 by W E Nesfield. Essex Vernacular style. One of a group of buildings designed by W E Nesfield in Radwinter following a disastrous fire, notable as an example of social housing.

Picture 1.11 Brookside Cottages by Nesfield

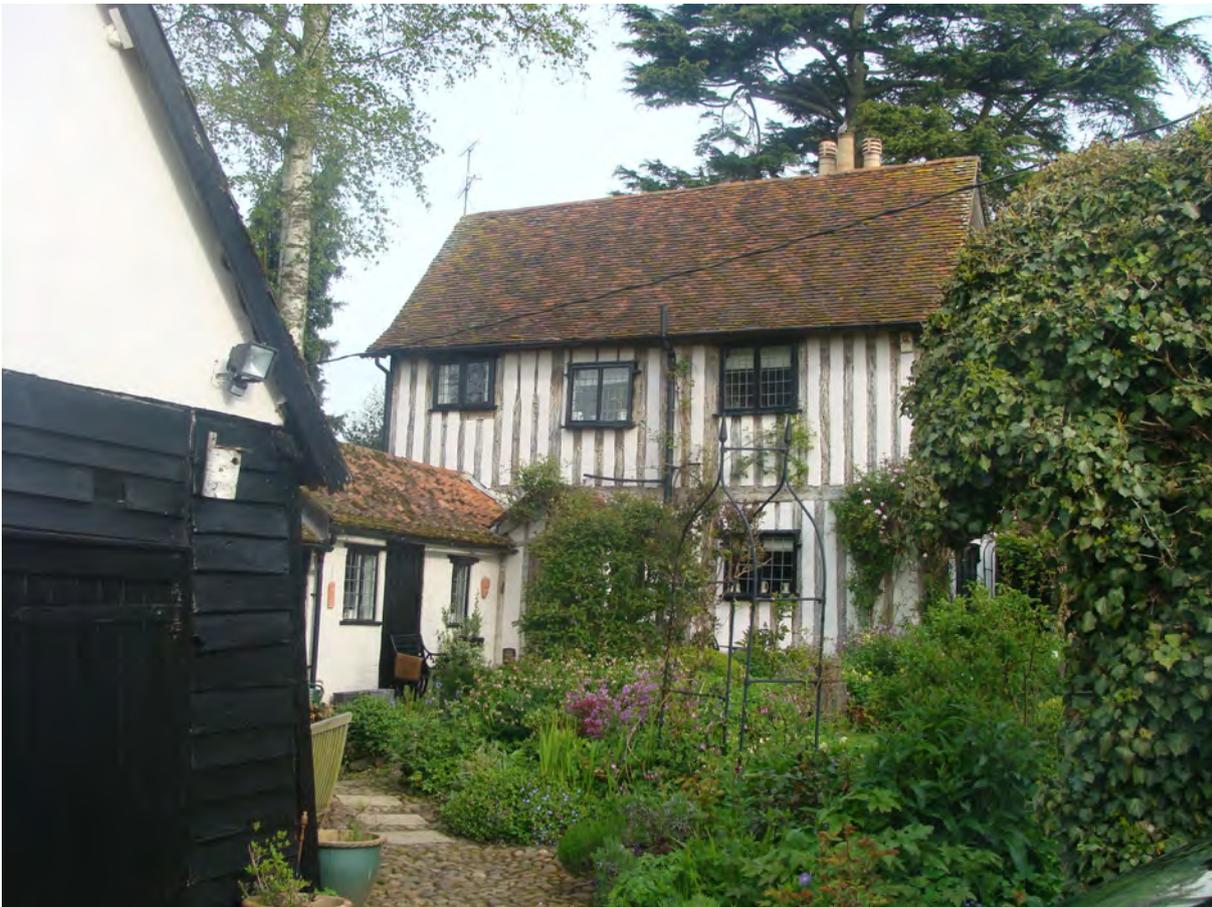
1.67 The Old Vicarage, Grade II* - 16th-17th century close-studded timber-framed and plastered building with modern alterations and addition on the south side. Two storeys and attics, with a garde-robe tower on the north-west corner. First floor jetty now under built and blocked oriel windows at east-end. A large external chimney stack projects on the north side (rebuilt at the top). The interior is largely unaltered, timber framing of good quality and 17th century panelled room. The Old Vicarage is a fine example of special quality and craftsmanship.

Picture 1.12 The Old Vicarage dating from the 16th century and listed Grade II*

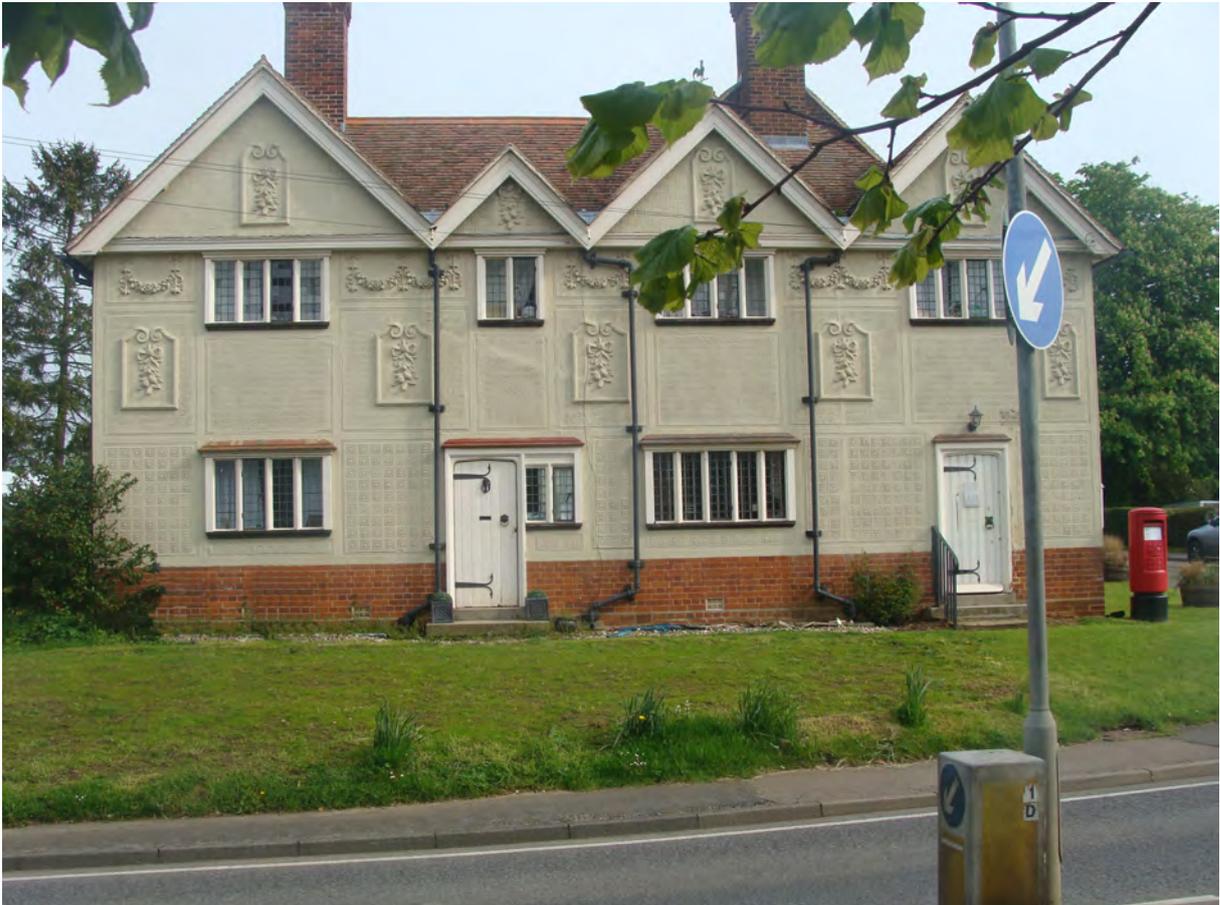
1.68 The Parish Hall - Grade II. Built in 1887 by W. E. Nesfield, architect. A red brick building with a plastered block at the south end with pargetted panels. The south front has 4 gables of different sizes. Roofs tiled, with 3 large square internal chimney stacks. *The building was originally a Reading Room and dispensary.*

Picture 1.13 Now the Parish Hall and cottage, formerly a Reading Room and Dispensary

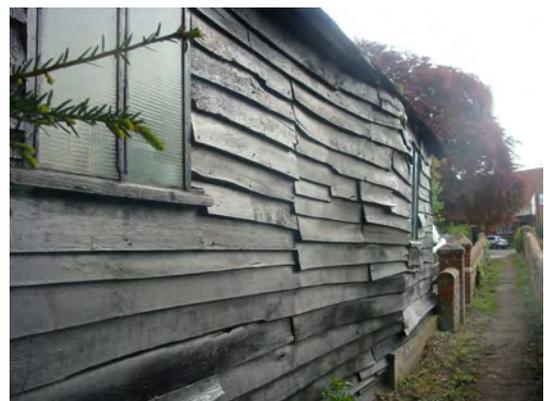
Picture 1.14 Weatherboarded barn of historic value within curtilage of the Old Vicarage

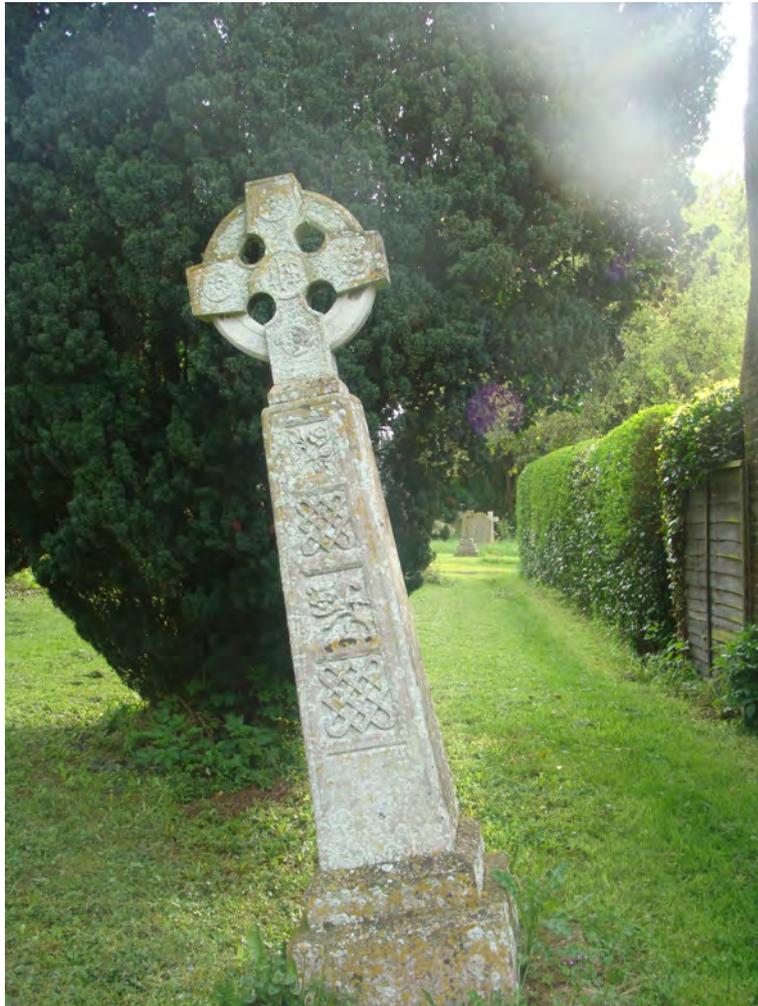
1.72 War Memorial commemorating the dead of both World Wars, tombstones and unusual metal grave markers within the churchyard. There are a wide range of such structures that add to the quality of the graveyard. Some are in need of resetting.

Picture 1.15 Within the churchyard there are many fine tombstones. Some may need re-setting

1.83 Opportunities to secure improvements. Seek owner's co-operation to replace decorative front boundary wall between Grove Cottage and the River Pant. Seek owner's co-operation to replace boundary between the Old Forge and churchyard with a hedge of native species. Consider re-setting selected leaning gravestones. Undertake a

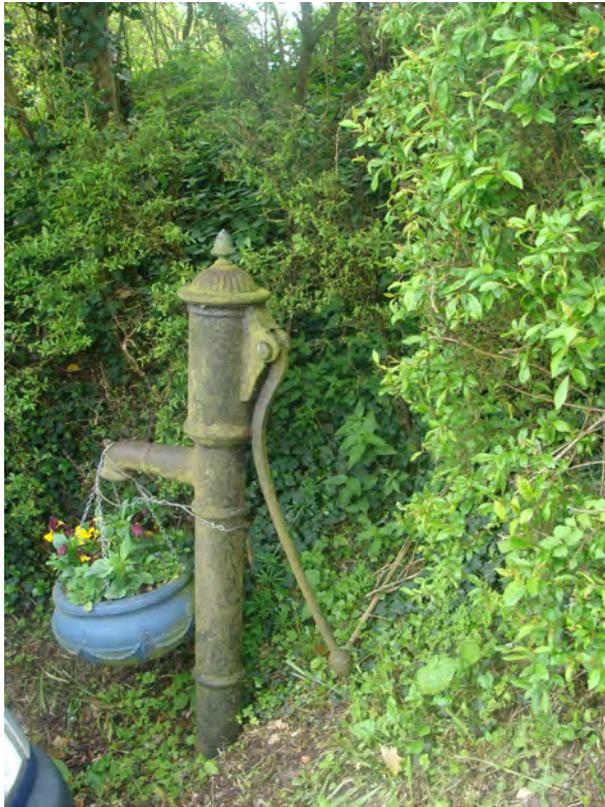
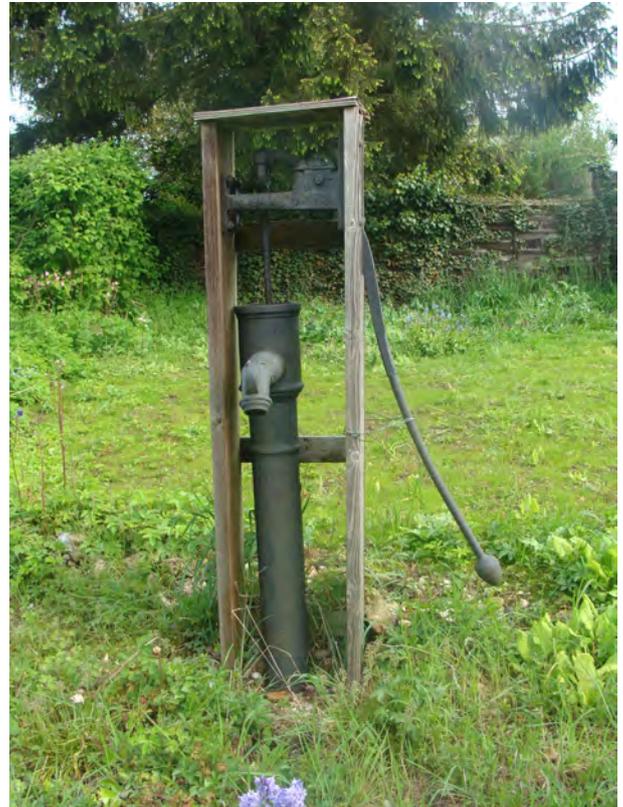
1.74 Other distinctive features that make an important architectural or historic contribution. 19th century pumps. Within Radwinter there are three 19th century pumps of quality. One located on the green sward to the front of the village hall is in urgent need of sensitive repairs. Another at Princes Well would benefit from being repainted whilst a similar pump located within the curtilage of residence to the immediate south of the school on Water Lane is largely hidden from view. A case could be made seeking the formal listing of the latter two.

The 19th century cast iron pump at Prince's Well needs repainting. It is a possible candidate for formal listing (left) and (right) another 19th century pump in need of sensitive repair

2.9 This Appraisal has identified several features including walls and pumps that make a particular contribution to the character of the Conservation Area. The walls identified are protected from demolition without prior consent virtue by Listed Building legislation and any proposal involving their demolition is unlikely to be approved. The unlisted pumps should be subject to application to English Heritage for formal listing. Should such an application fail other mechanisms to achieve their protection should be explored.

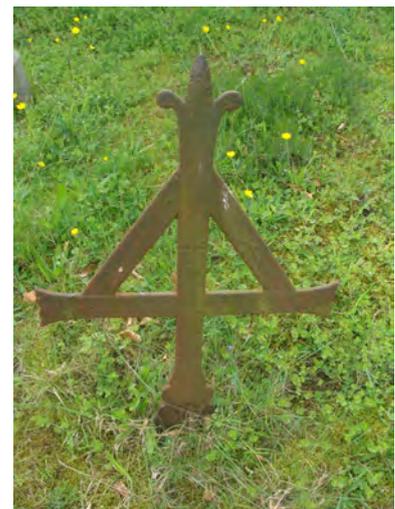
Picture 1.16 Unusual metal grave marker. Is there any further local knowledge regarding these?

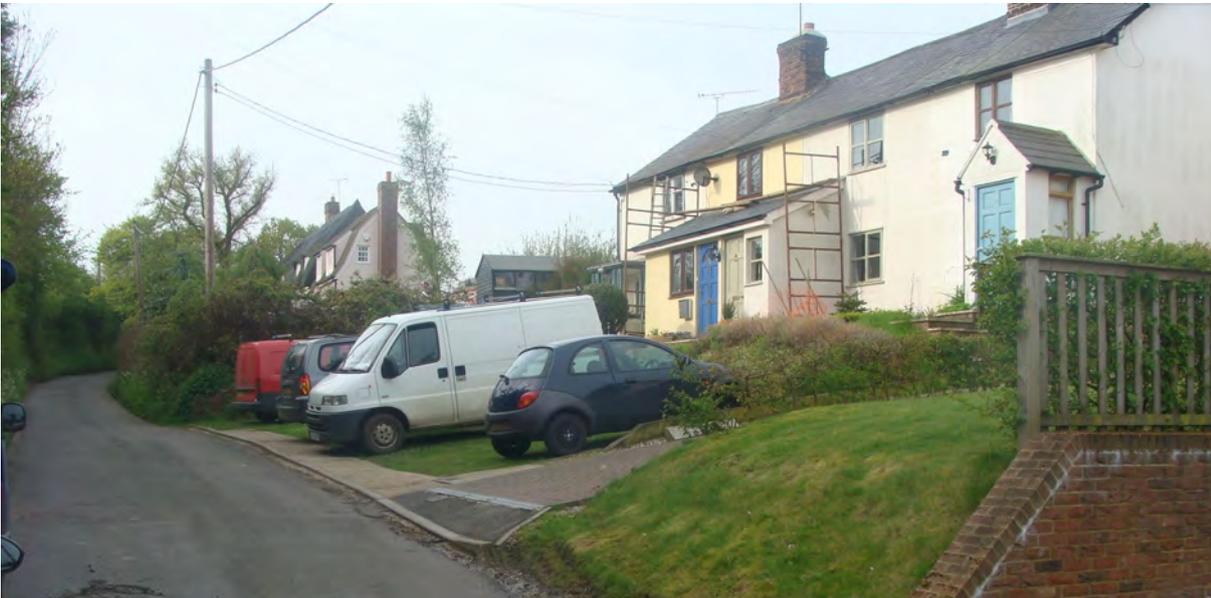
1.78 Elements that are out of character with the Conservation Area. The area to the south of the River Pant to the western side of the road consists of a grouping of late 19th/early 20th century properties whose historic and architectural qualities have been eroded by extensions and additions to the front elevations and by parking bays that detract from the quality of the street scene.

Picture 1.17 Late 19th/early 20th century terrace whose qualities have been eroded by porches to front and parking. The detail as to whether or not these developments represent 'permitted development' has not been checked in detail. However on the assumption that some developments fall into that category, the resultant detrimental impact on the local street scene certainly illustrates the value of the general principle of introducing Article 4 Directions within Conservation Areas in appropriate situations.

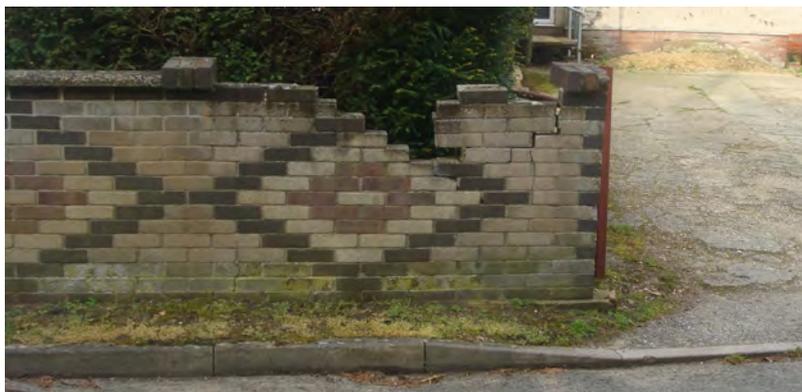
1.79 In the same general area between Grove Cottage and the River Pant is a decorative wall in poor condition that ideally needs replacing with more appropriate boundary detailing.

Picture 1.18 Modern decorative wall in very poor condition

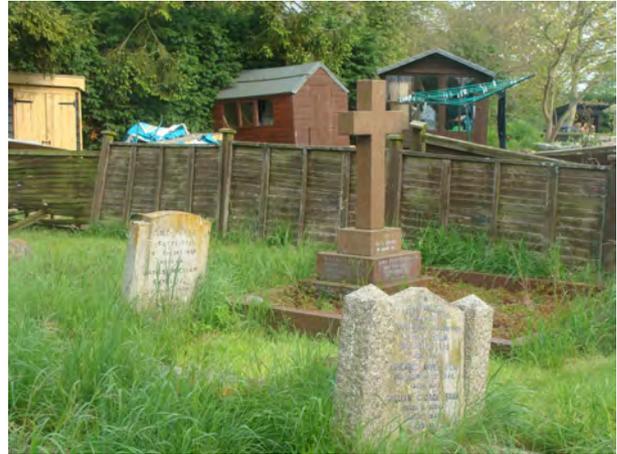
1.80 Poor quality boundary fencing to the rear of the Old Forge and forming boundary with the churchyard. This dilapidated fence detracts from the quality of the churchyard in this location; ideally needs replacing with hedge of native species.

Picture 1.19 Poor quality boundary fence replaced by native species hedge would represent a significant environmental gain

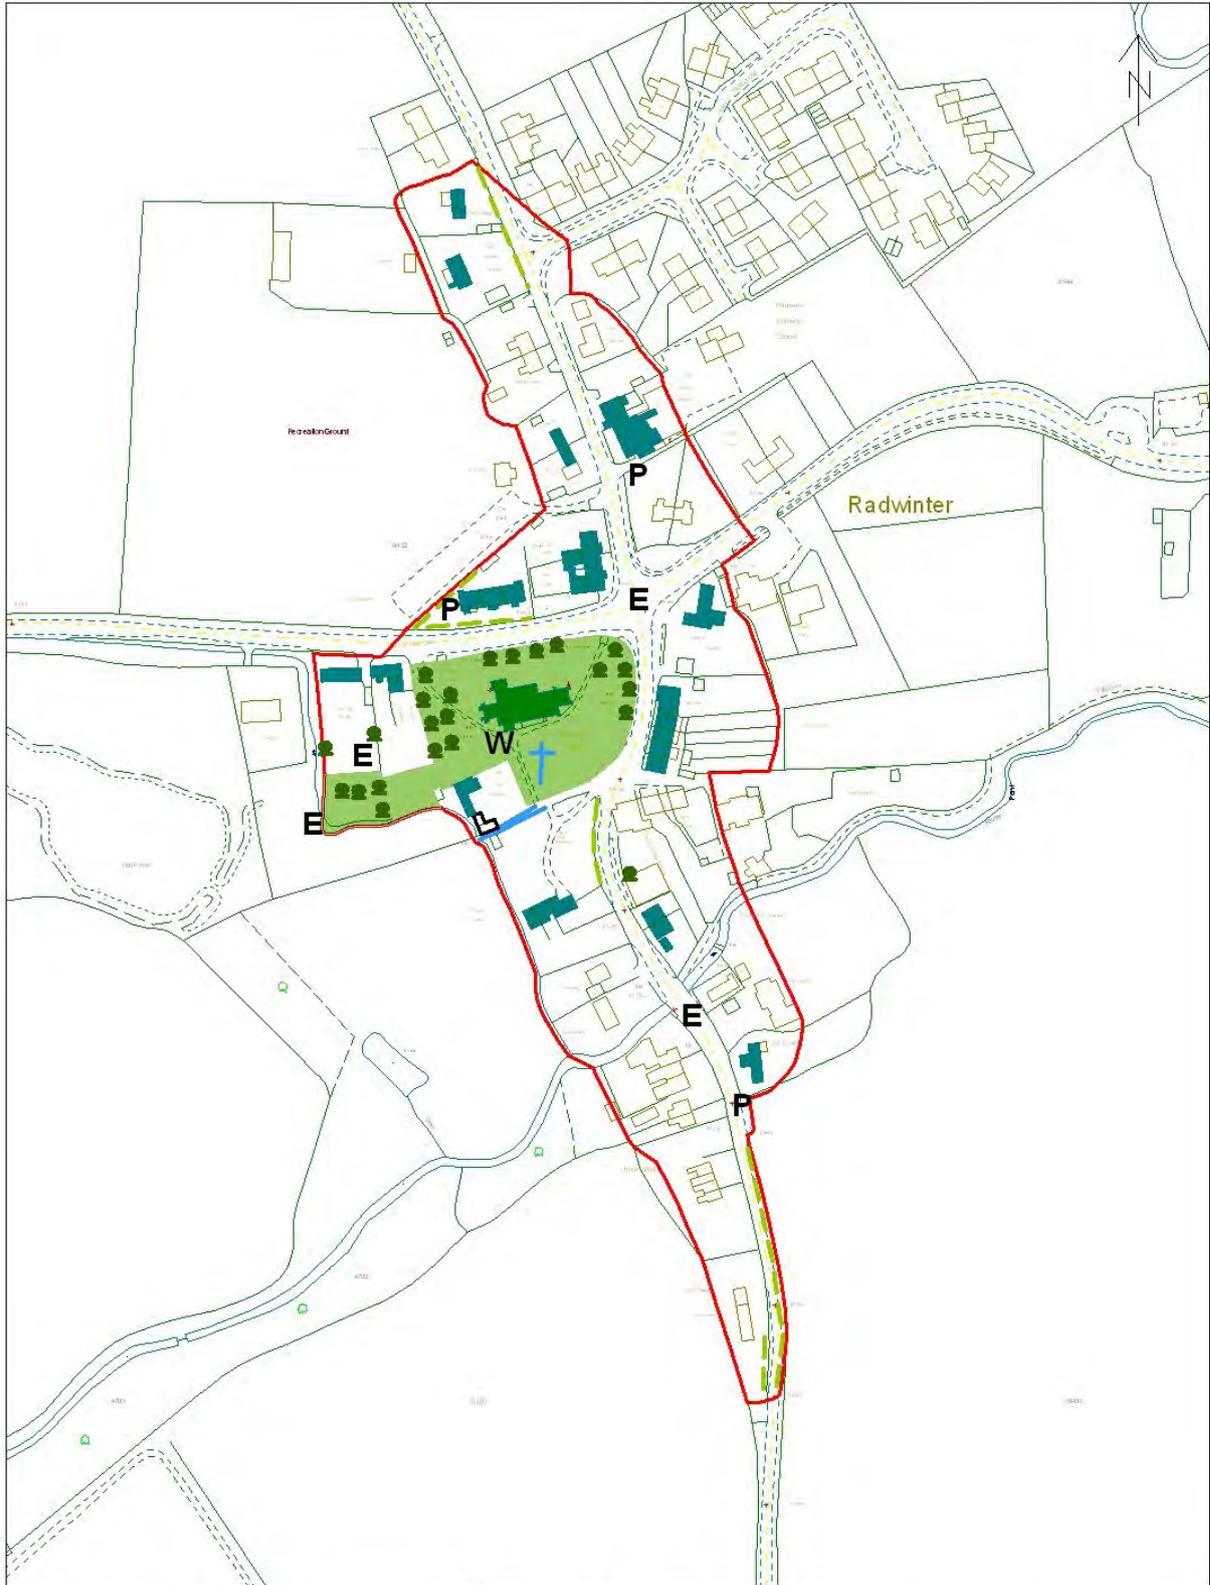
Figure 4 - Management Plan

<p>Radwinter Conservation Area Appraisal Management Plan</p>	<p>Reproduced from the Ordnance Survey mapping with permission Crown Copyright. Unauthorised reproduction infringes Crown Copyright and may lead to prosecution or civil proceedings. Uttlesford District Council Licence No: 100018688 (2004). DATE:13/08/2012 MAP REFERENCE:IL6037SE SCALE:1:1700</p>
--	--
