Radwinter Conservation Area Appraisal and Draft Management Proposals, 2012

Part 1: Appraisal 1

Introduction

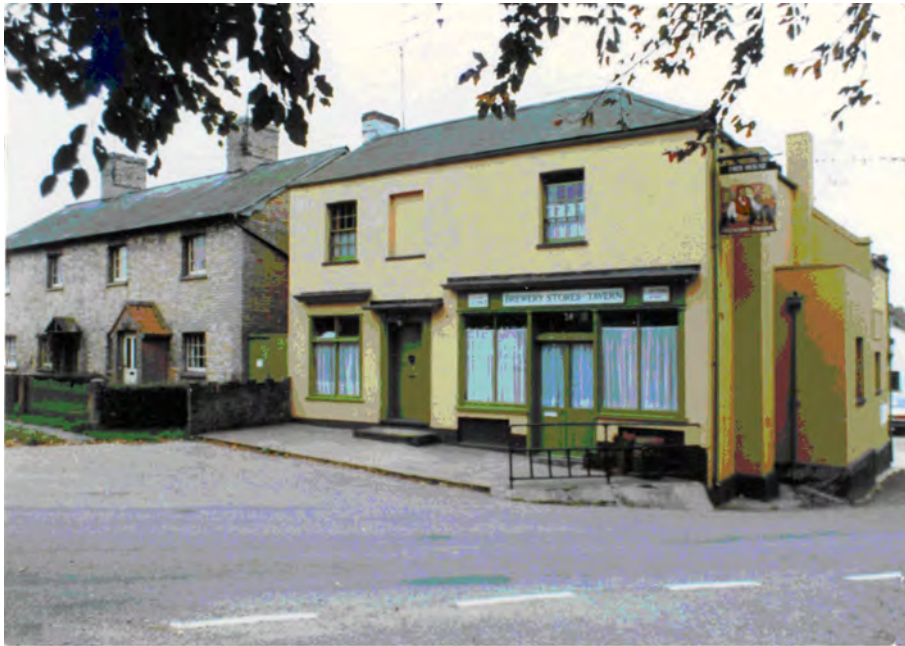
Picture 1.2 Traditional village shop and residence, mid/late 20th century, additional use as Brewery Tavern and enlarged window to left added. Also note porches of differing styles and scales added to adjoining 19th century terrace

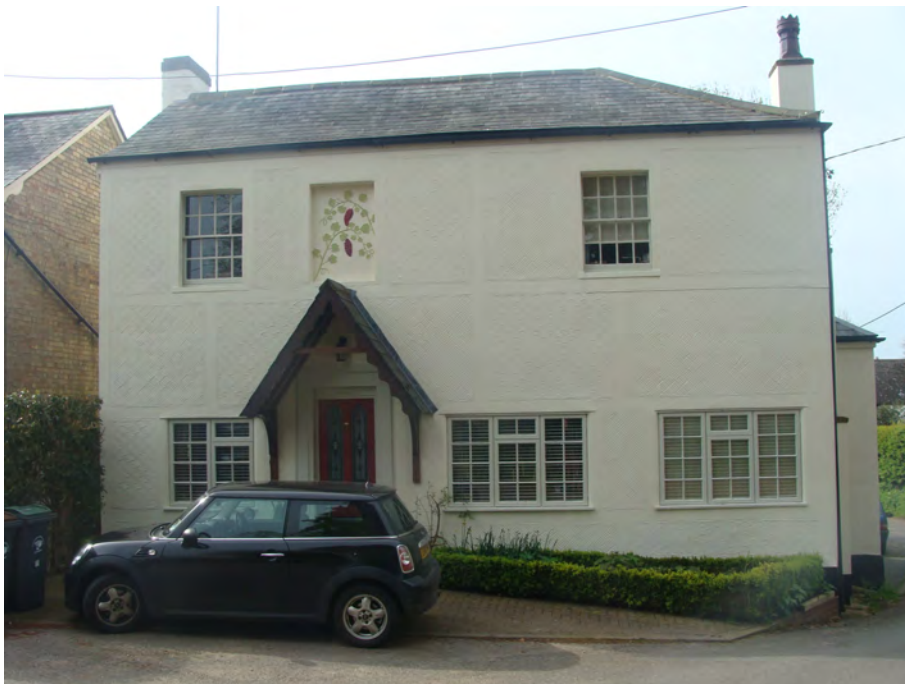
Picture 1.3 The building today, original commercial window detailing replaced and large central porch added. Change of use may have been inevitable but a more appropriate design solution retaining some original features would have been possible

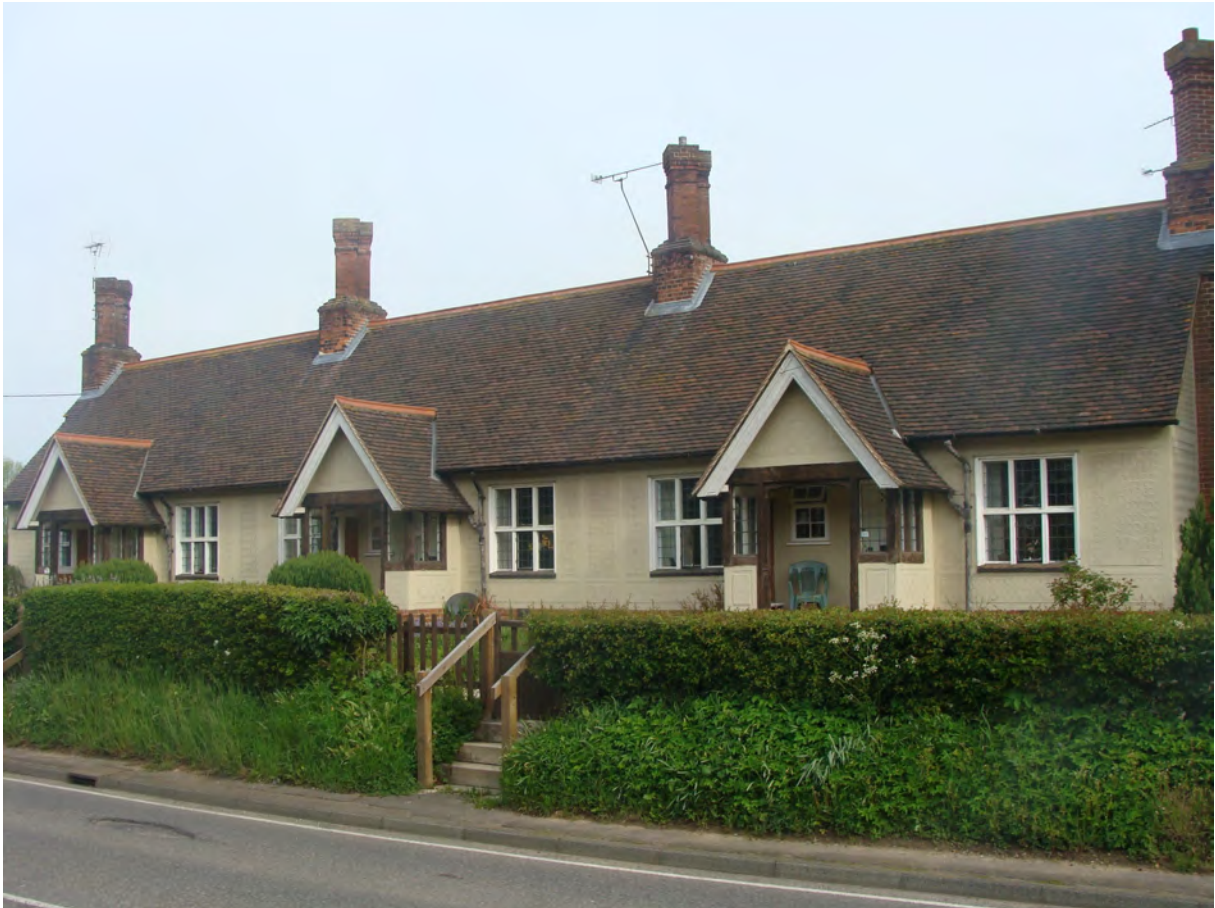
1.63 Almshouses Nos. 1, 2 and 3 Ashdon Road - Grade II. Range of almshouses built by W. E. Nesfield, architect, in 1887. The walls are plastered, with pargetted panels, on a red brick base. The windows are casements with leaded lights and wood mullions and transoms. Three gabled porches project on the front. Roofs tiled, with 4 chimney stacks each with 2 square shafts set diagonally on a square base. *James Bettley and Pevsner advise these were in fact designed by Temple Moore, a protégé of Nesfield.*

Picture 1.9 Alms Houses designed by Nesfield and/or Temple Moore

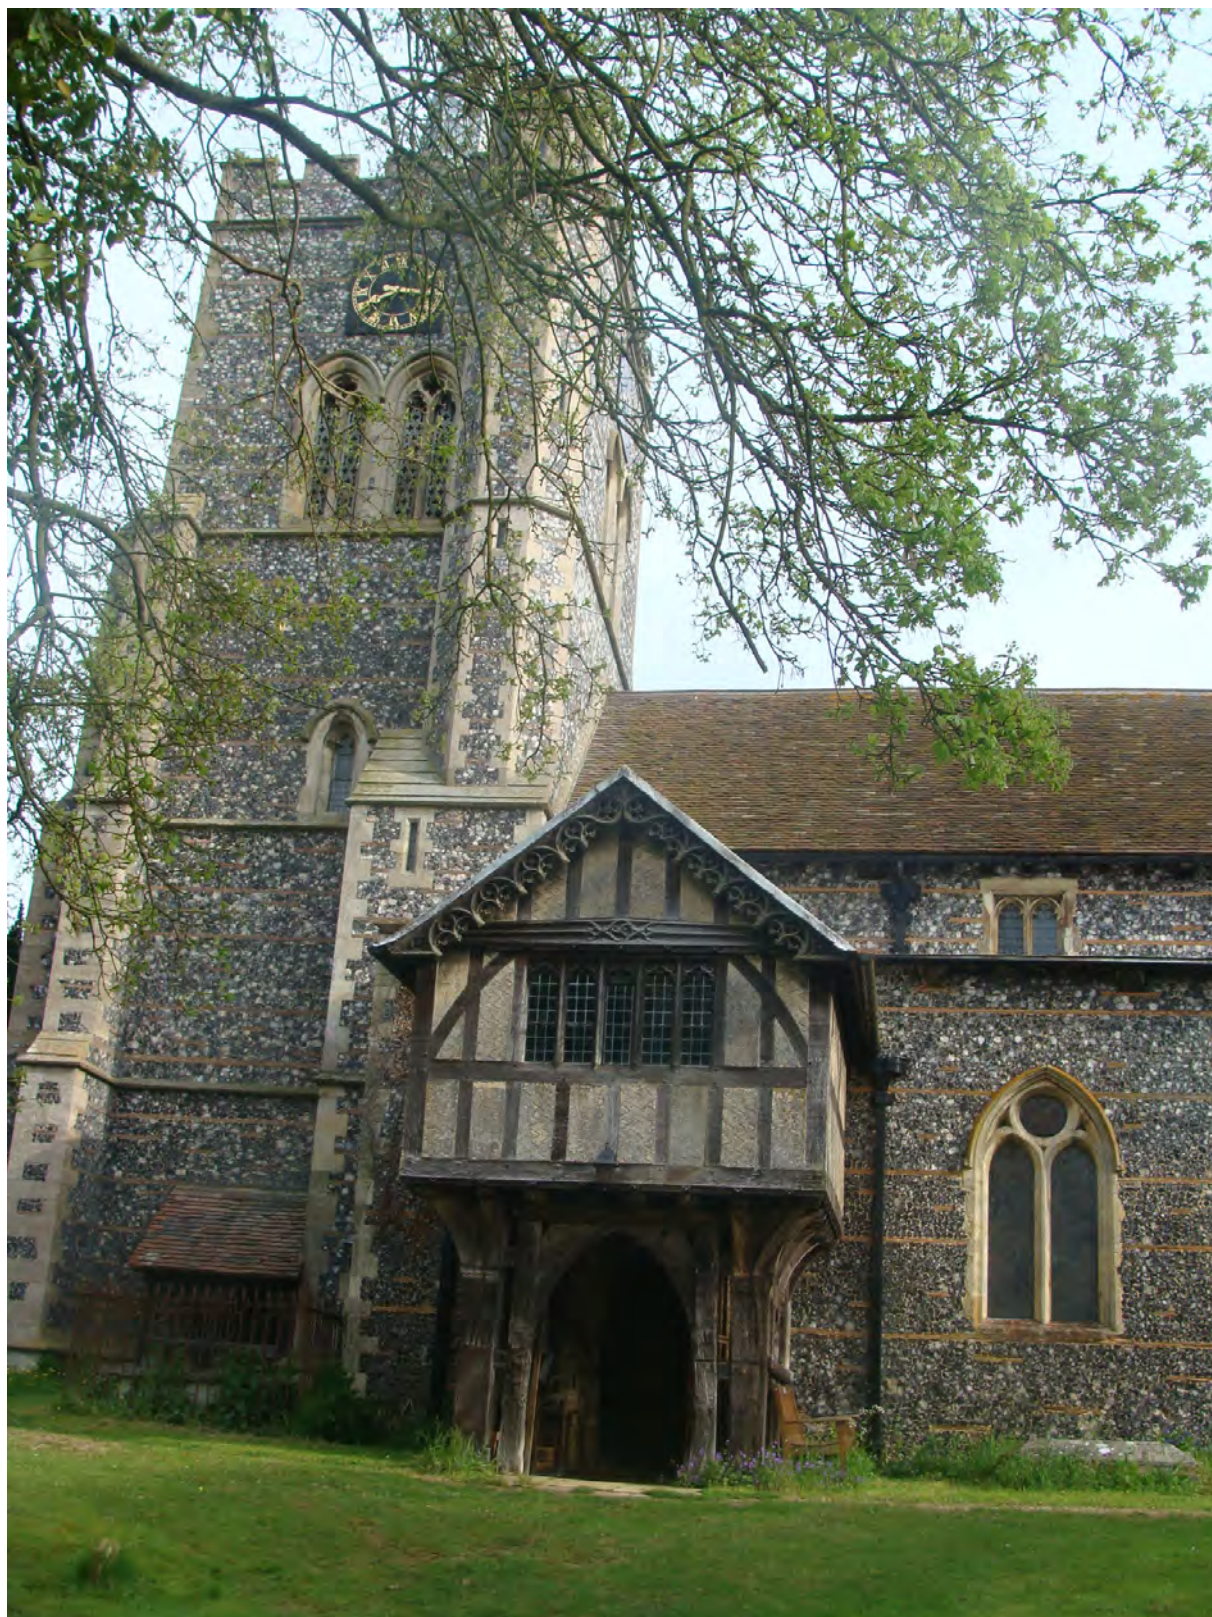
1.64 Church of St Mary the Virgin - Grade II*. Flint church almost completely rebuilt in 1869-70 by W. E. Nesfield. He left the lower stage of the fine 14th century south porch and the north arcade of the nave which is circa 1340. He added the gabled framed upper storey of the south porch. The nave roof is 14th century. The west tower, with castellated parapet, angle buttresses staircase turret and small spire was added in 1887 by Temple Moore. The church reconstruction with a number of surrounding buildings is an important work of W. E. Nesfield. *Within the church is a rare 16th century wooden Reredos made in Brussels and bought by Bullock; 19th century side wings by unknown artist were commissioned by Temple Moore. Fine stained glass throughout; one scene has given biblical characters the contemporary faces of Gladstone, the Prime Minister (a very good likeness) and Lord Salisbury, for example. Also other fine paintings and other internal features by Temple Moore and Nesfield.*

Picture 1.10 Radwinter church, note similarity of porch with Nesfield's original sketch, see Picture 1.5 above

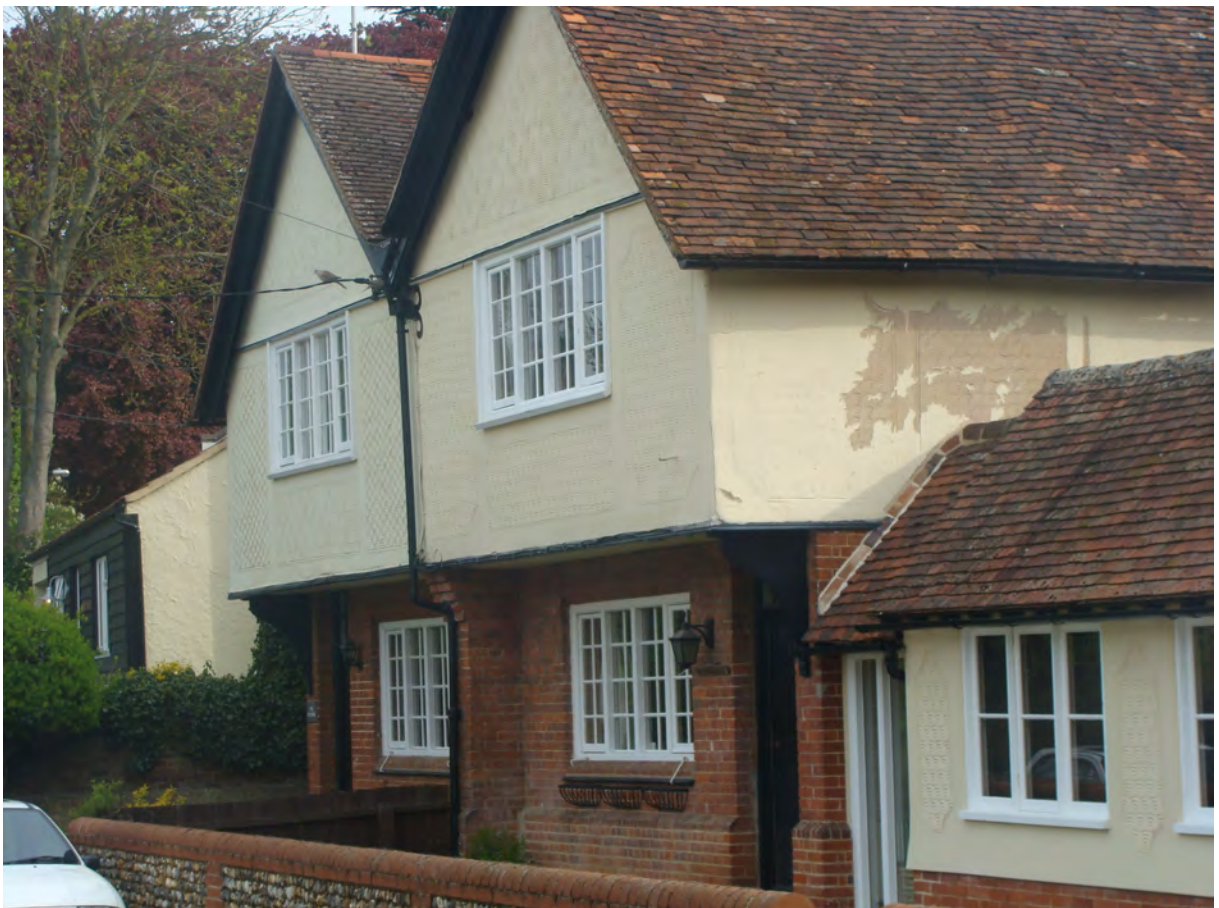
1.65 Brookside Cottages including outbuilding to south, Princes Well - Grade II. Pair of cottages and outbuilding, formerly a tailor's shop. Circa 1875 by W E Nesfield. Essex Vernacular style. One of a group of buildings designed by W E Nesfield in Radwinter following a disastrous fire, notable as an example of social housing.

Picture 1.11 Brookside Cottages by Nesfield

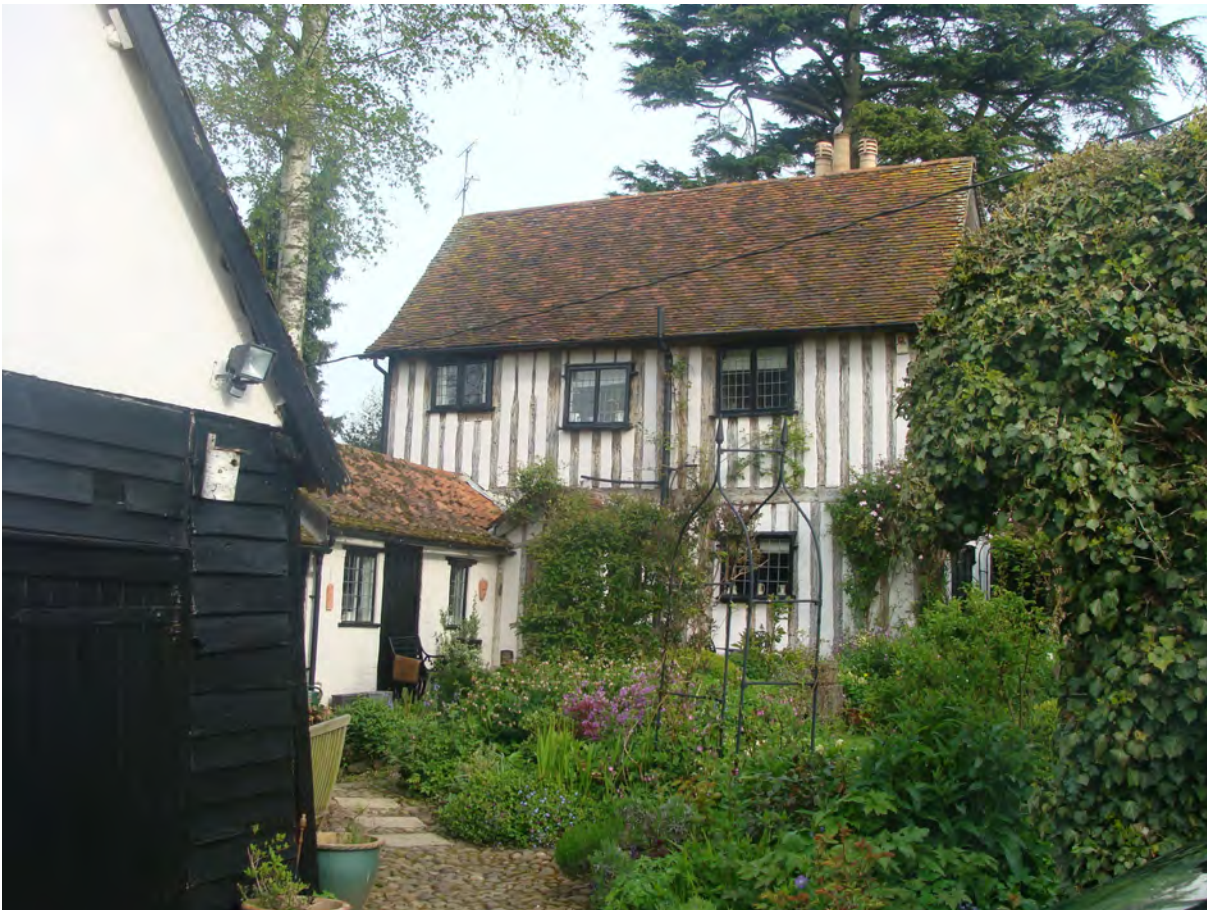
1.67 The Old Vicarage, Grade II* - 16th-17th century close-studded timber-framed and plastered building with modern alterations and addition on the south side. Two storeys and attics, with a garde-robe tower on the north-west corner. First floor jetty now under built and blocked oriel windows at east-end. A large external chimney stack projects on the north side (rebuilt at the top). The interior is largely unaltered, timber framing of good quality and 17th century panelled room. The Old Vicarage is a fine example of special quality and craftsmanship.

Picture 1.12 The Old Vicarage dating from the 16th century and listed Grade II*

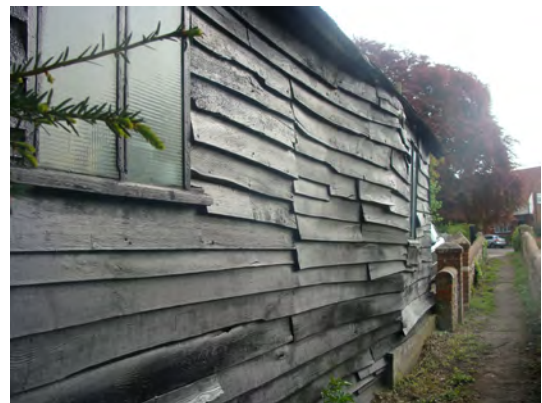
Picture 1.14 Weatherboarded barn of historic value within curtilage of the Old Vicarage

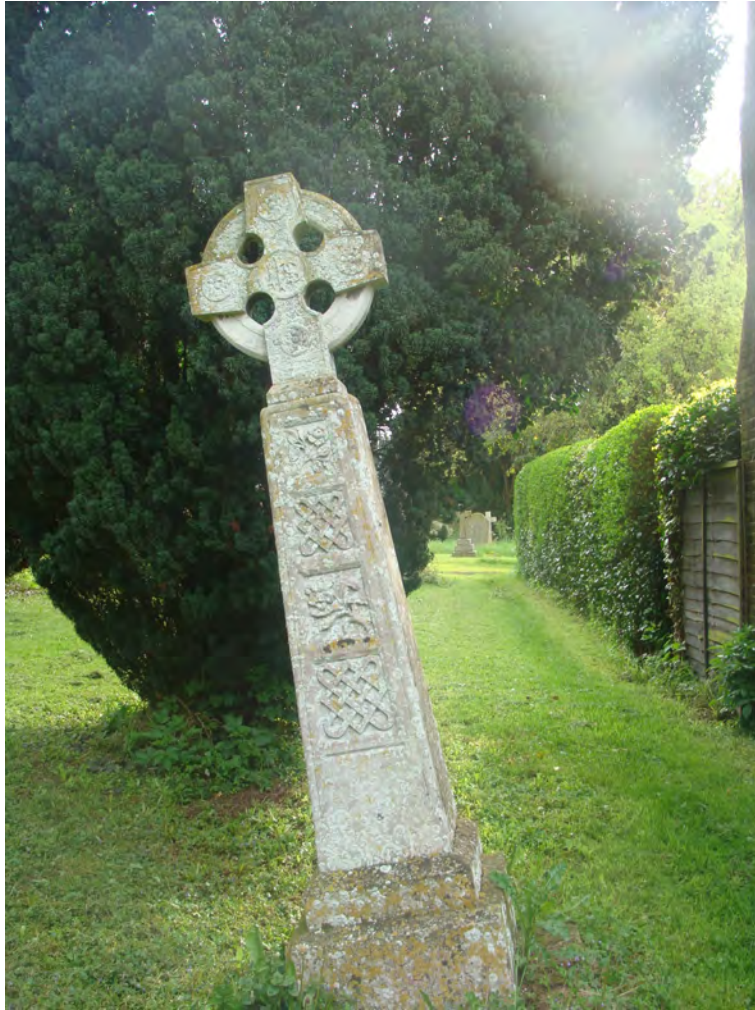
1.72 War Memorial commemorating the dead of both World Wars, tombstones and unusual metal grave markers within the churchyard. There are a wide range of such structures that add to the quality of the graveyard. Some are in need of resetting.

Picture 1.15 Within the churchyard there are many fine tombstones. Some may need re-setting

1.83 Opportunities to secure improvements. Seek owner's co-operation to replace decorative front boundary wall between Grove Cottage and the River Pant. Seek owner's co-operation to replace boundary between the Old Forge and churchyard with a hedge of native species. Consider re-setting selected leaning gravestones. Undertake a

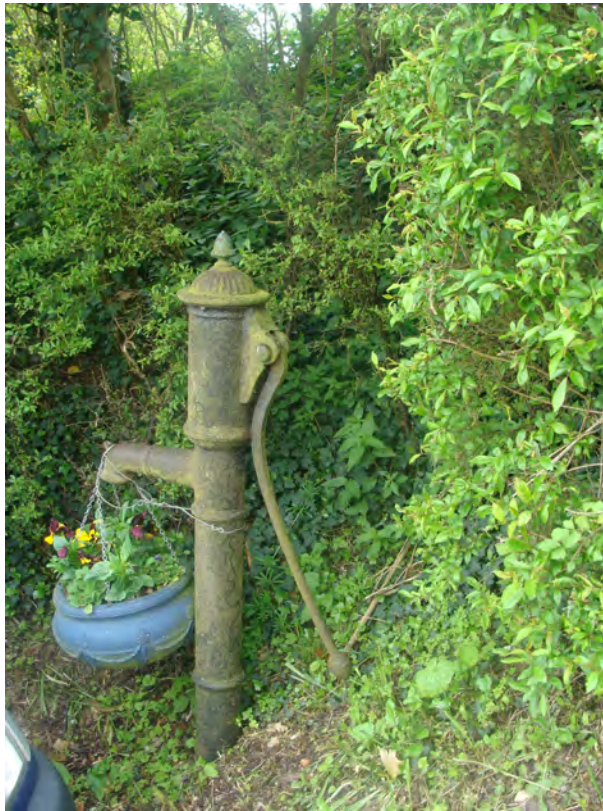
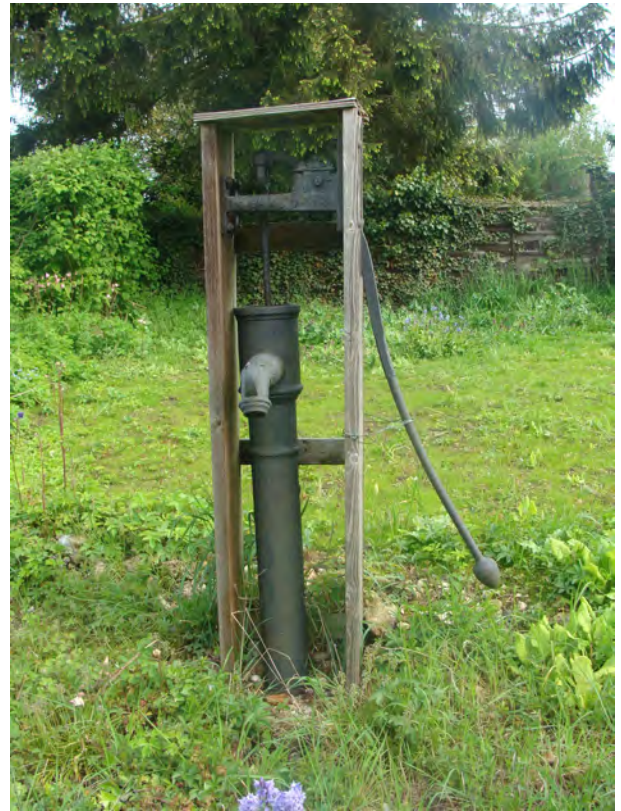
1.74 Other distinctive features that make an important architectural or historic contribution. 19th century pumps. Within Radwinter there are three 19th century pumps of quality. One located on the green sward to the front of the village hall is in urgent need of sensitive repairs. Another at Princes Well would benefit from being repainted whilst a similar pump located within the curtilage of residence to the immediate south of the school on Water Lane is largely hidden from view. A case could be made seeking the formal listing of the latter two.

The 19th century cast iron pump at Prince's Well needs repainting. It is a possible candidate for formal listing (left) and (right) another 19th century pump in need of sensitive repair

2.9 This Appraisal has identified several features including walls and pumps that make a particular contribution to the character of the Conservation Area. The walls identified are protected from demolition without prior consent virtue by Listed Building legislation and any proposal involving their demolition is unlikely to be approved. The unlisted pumps should be subject to application to English Heritage for formal listing. Should such an application fail other mechanisms to achieve their protection should be explored.

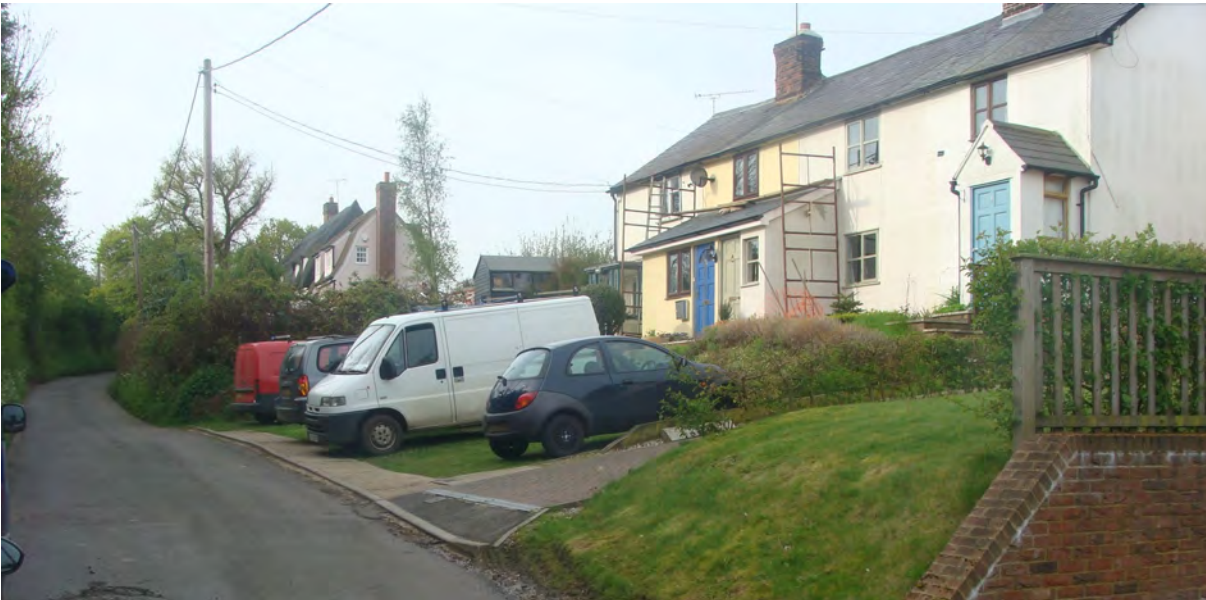
1.78 Elements that are out of character with the Conservation Area. The area to the south of the River Pant to the western side of the road consists of a grouping of late 19th/early 20th century properties whose historic and architectural qualities have been eroded by extensions and additions to the front elevations and by parking bays that detract from the quality of the street scene.

Picture 1.17 Late 19th/early 20th century terrace whose qualities have been eroded by porches to front and parking. The detail as to whether or not these developments represent 'permitted development' has not been checked in detail. However on the assumption that some developments fall into that category, the resultant detrimental impact on the local street scene certainly illustrates the value of the general principle of introducing Article 4 Directions within Conservation Areas in appropriate situations.

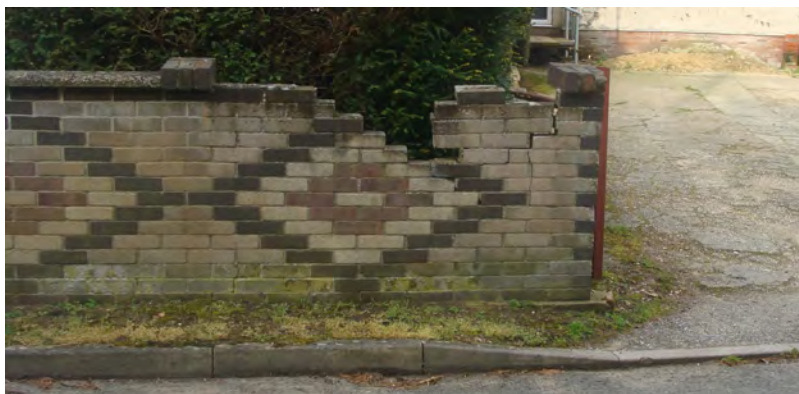
1.79 In the same general area between Grove Cottage and the River Pant is a decorative wall in poor condition that ideally needs replacing with more appropriate boundary detailing.

Picture 1.18 Modern decorative wall in very poor condition

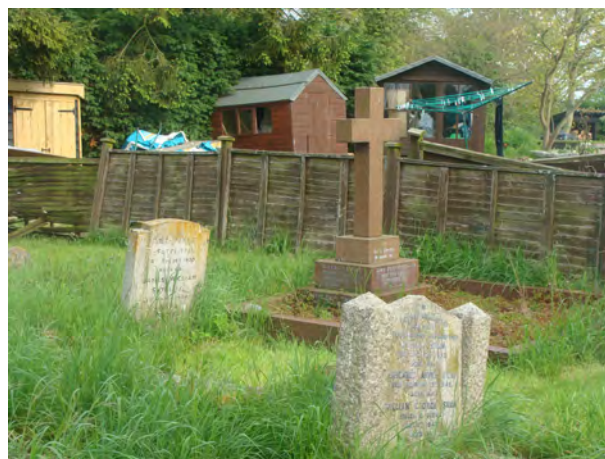
1.80 Poor quality boundary fencing to the rear of the Old Forge and forming boundary with the churchyard. This dilapidated fence detracts from the quality of the churchyard in this location; ideally needs replacing with hedge of native species.

Picture 1.19 Poor quality boundary fence replaced by native species hedge would represent a significant environmental gain
